## UAS SITKA CAMPUS CONDITION SURVEY

## EXECUTIVE SUMMARY

This report presents the findings of a conditions survey conducted at the campus of the University of Alaska Southeast Sitka Campus. The purpose of the conditions survey is to identify major maintenance, code, program, obsolescence and other deficiencies that we found on the campus, including buildings, site features, and utilities. The conditions survey team includes:

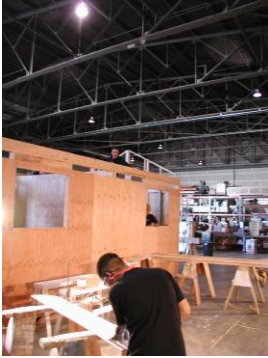
2. Exiting from the undeveloped hangar area (*fig 8*): There are several programs taught in the undeveloped hangar area, including carpentry, small engine repair, construction etc. In addition, welding activities have occasionally taken place in the open hangar area. These areas should be separated by one hour wall, or a combination of sprinklers and smoke barrier wall (IBC 2006 Table 508.2). In addition, exiting is defined only by walkways painted on the floor. The painted exit pathway solution is a temporary agreement with the local building official with the understanding that code compliant exits will be provided as the spaces are developed. The Health Sciences addition includes an exit to the south side of the building and provides a dedicated exit for the existing construction lab area. The dedicated construction lab exit can be extended in the future to provide an additional dedicated exit to the open project area of the hangar as well as serve as the exit required for Commons 102 mentioned in item 1 above. However, the lack of separation between the carpentry area and the undeveloped hangar area continues to be a problem. A wall should be established to separate the two. A wall in this location has been discussed in the past, is consistent with the overall campus masterplan and would also serve to resolve dust and noise issues between the spaces. Figure 8 illustrates the condition- the open projects area in the foreground is open to the technology classroom beyond.

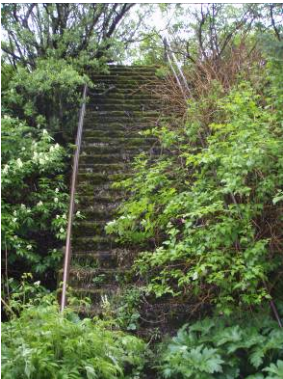
Derelict stairs at South Side of building

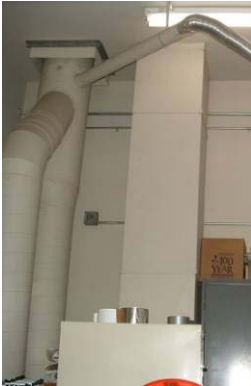
Several modifications have been made to AHU-1 duct system. Variable air volume terminal boxes are first generation air valve type. They should be replaced.

**AHU-1 SUPPLY DUCT  
WITH  
MODIFICATIONS –  
NOTE SMALL DUCT  
ADDED**

**Item 1:** AHU-1 System VAV Box Replacement. Replace the first generation variable air volume pneumatic terminal boxes (20) with modern DDC boxes for better control and energy savings, connect to DDC system. RR, EE.

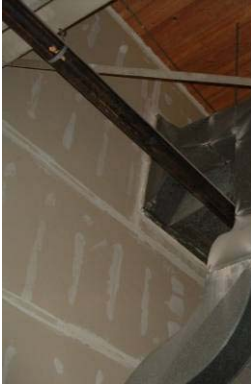
**EF-3 DISCHARGE, NOTE DUST ESCAPING DUCT SEAMS**

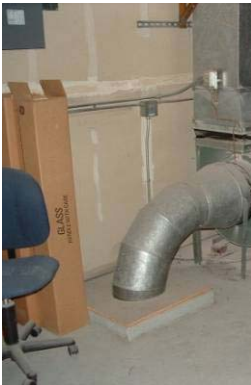
**EF-3, NOTE DUST AROUND FAN**

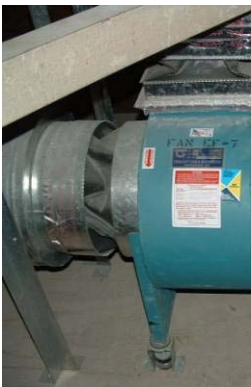
EF-7

**Boiler Room Exhaust Fan:** A sidewall exhaust fan controlled by a room thermostat is located in the wall of the Boiler Room. Fan is in fair condition but is undersized for the room and could be interfering with combustion air flow.

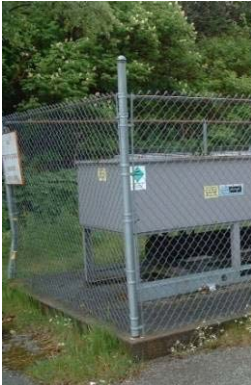
**WATER CHILLER**

The chiller has not been used recently and has reportedly

been idle since shortly after the original installation. Originally there was anticipated to be heavy cooling loads required for the programs intended but these programs did not materialize and the cooling ability of the chiller was not needed.
