## UAS SITKA CAMPUS CONDITION SURVEY

## EXECUTIVE SUMMARY

This report presents the findings of a conditions survey conducted at the campus of the University of Alaska Southeast Sitka Campus. The purpose of the conditions survey is to identify major maintenance, code, program, obsolescence and other deficiencies that we found on the campus, including buildings, site features, and utilities. The conditions survey team includes:

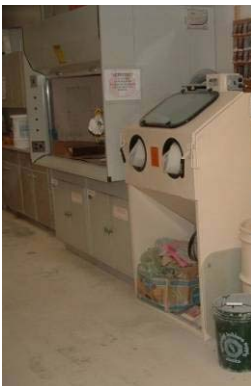
**FUME HOOD, SAND BLAST ABRASION CENTER**

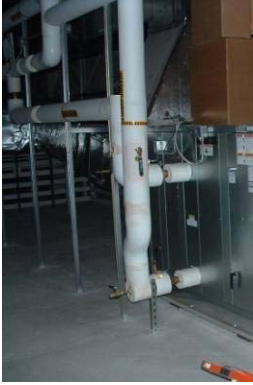
Ventilation unit AHU-5, is located on the mezzanine above the Welding Shop Area on the second story of that addition, and supplies make-up air and supply air heating and ventilation air for the Welding Shop area. Outside air is taken in through a louver located on the south side of the building. AHU-5 Heating Coil has Face & Bypass dampers useful for full outside air operation when in make-up air mode, as occurs when welding shop exhaust fans are operating. AHU-5 is a recent addition (2005) and in good condition.

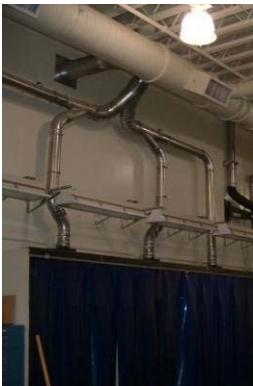
**WELDING SHOP EXHAUST FANS EF-10, EF-11, EF-12, EF-13, and EF-13**, located on the mezzanine above the second story of the welding shop addition, serve multiple welding stations in the welding shop below. The exhaust fans are Nederman utility sets and are in good condition.

WELDING BOOTHS EXHAUST AIR MANIFOLD, ARM

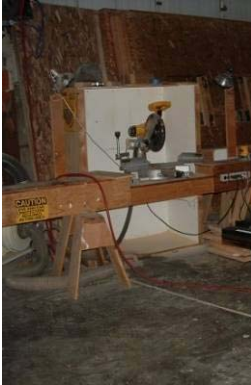
A portion of the open unheated work space in the hanger facility contains wood shop and carpentry equipment. The Wood Shop classroom is sprawled about in the open western space part of the Hangar space. The dust collection system is comprised of a self contained portable system with two portable dust collection canisters and flexible duct connections. However, this type of dust collection is not acceptable for meeting code requirements for wood shop classroom settings.

**WOOD SHOP EQUIPMENT**

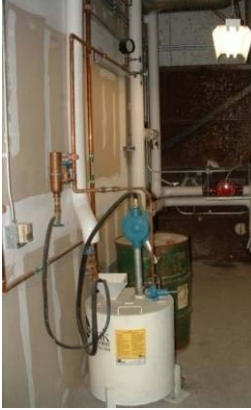
The chiller has not been used recently and has reportedly

been idle since shortly after the original installation. Originally there was anticipated to be heavy cooling loads required for the programs intended but these programs did not materialize and the cooling ability of the chiller was not needed.

**Chiller Circulation Pump and Glycol Fill Station.**

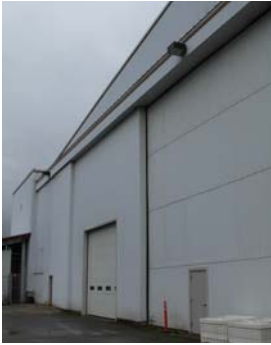
Fig. 7:Exterior Wall-mounted Luminaires

- The luminaires mounted to the exterior of the building (Figure 10) and on the parking area light poles are rectangular box type with controlled and cutoff type distributions. The lamps are high pressure sodium presenting a golden color (Figure 7).

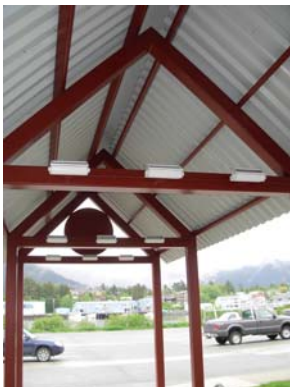
Fig 8: Entrance Canopy Lighting

- The luminaires under the sidewalk canopy at the entrance present indirect illumination of the ceiling with a metal halide type lamp (Figure 8).
- Floodlights are mounted to the ground inside canisters with windows along the front of the building, aimed to illuminate the building. The lamps appear to be metal halide (Figure 9).

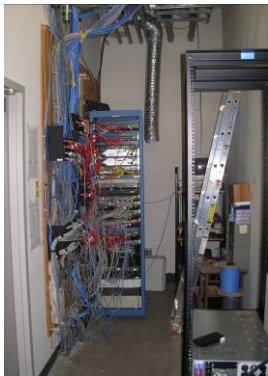
- The network system (Figure 12) incorporates Category 5 and 5e cables routed from an array of patch panels mounted to a plywood board on the wall of the telephone utility room to terminals scattered around the building. The terminals are patched into network switches located in an adjacent rack with patch cables. The terminals at the computer work stations utilize RJ45 jacks.

- The telephone and network cables in the originally constructed area are routed in the ceiling cavities with no supporting structures. Some of the original telephone cables utilize conduits from the ceiling cavities to

Fig 12: Network Rack and Distribution System

boxes in the walls for their terminals. Most of the telephone and network cables are installed in surface mounted raceways on the walls, or “fished” into the walls.
